ES Radio System Access Issues on P25 Trunking Systems

FSB-0513-ESACCS-02

Affected Products: 5100ES / 5300ES Radios with Software Versions 6.12.x or Higher

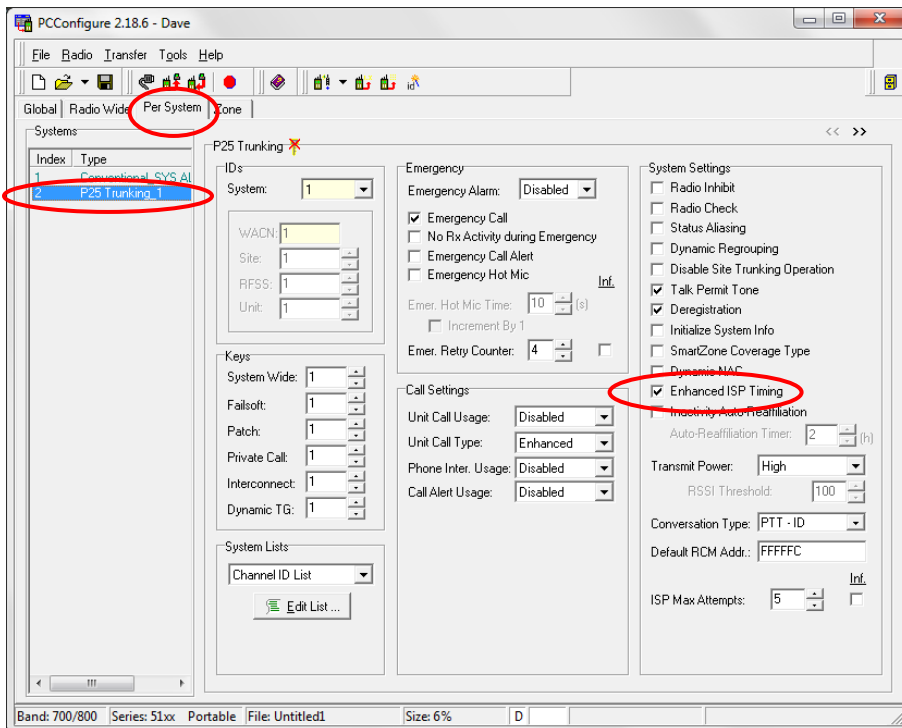
Symptom(s): Radios with the Enhanced ISP Timing option enabled may experience an increased number of system access retries on legacy P25 Trunking systems.

Cause: In the 6.12.x version of firmware, an Enhanced ISP option was added to the P25 Trunking system settings. It was added in the 09.2 Software Release and is needed to pass CAP testing.

Resolution: Disable or uncheck the Enhanced ISP Timing option found in the P25 Trunking Per System folder.
