Viking Subscriber Software 21.1.1 Maintenance Release

Effective Release: May 23, 2022

FSN-0522-VIKING-22

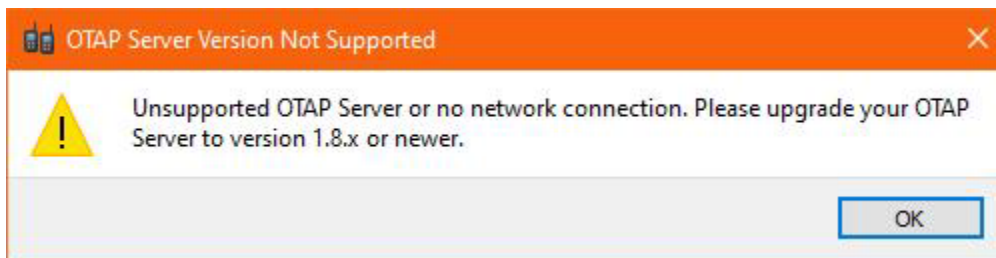
Armada users connecting to OTAP Server will receive the below error notification as of May 20, 2022, and will be unable to perform OTAP operations. The OTAP Connection Test will also fail.

Issue	Overview
OTAP Server Connection Failure	A security certificate expired for the OTAP Server software as of May 20, 2022. Armada will report an OTAP Server Version error with the message "Unsupported OTAP Server or no network connection. Please Upgrade your OTAP Server..." and the OTAP Connection Test will fail. This version of OTAP Server and Armada corrects the issue.
Missed Emergency Alert on Traffic Channel	Added support for a previously unsupported Emergency Alarm message format from another manufacturer.
Handling of Invalid Two-Tone	If the radio received an invalid two-tone sequence prior to a valid sequence in the same transmission, the valid sequence would get ignored. This has been addressed, and the radio will unmute when a subsequent valid sequence is received.
Emergency call handling with security override	In a specific system configuration, PTT was being denied during Emergency when the Channel had Security Override Set. This fix forces the use of Talk Group security settings versus override settings during Emergency for this scenario.

Please upgrade OTAP Server and Armada to the versions listed in this notice or later to resolve this issue.
